*TRAFFIC ENGINEERING  
DEMONSTRATION PROJECT ON  
U.S. 52 BYPASS  
INVENTORY, ANALYSIS AND RECOMMENDATIONS*

*MAY 1966  
NO. 8*

*Joint  
Highway  
Research  
Project*

Progress Report

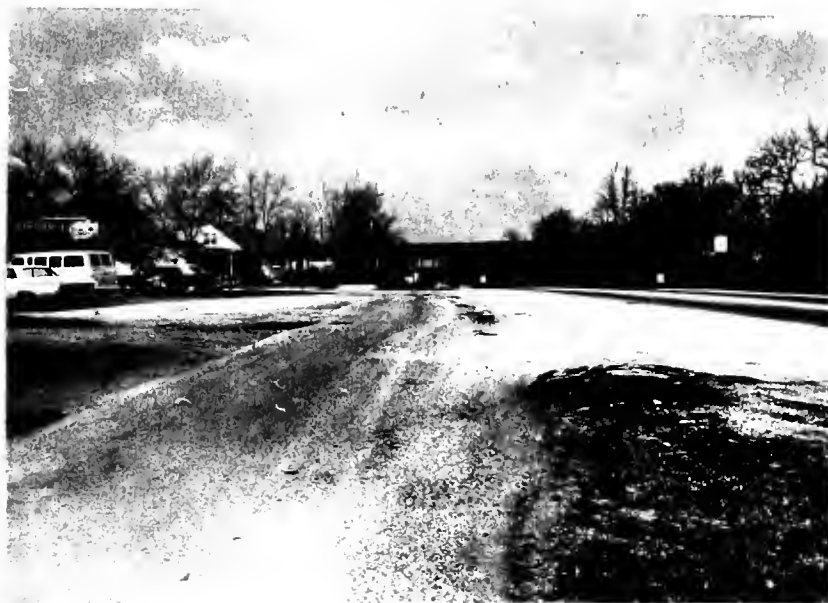
FIGURE 21 NORTHWEST QUADRANT OF INDIANA  
25 INTERSECTION - POOR DRIVEWAY  
DELIMITATION
